# #14728: Special Coverage Adjustment - Cracked Fuel Tank Inlet Control Valve - (Jul 23, 2015)

**Subject: 14728 – Special Coverage Adjustment – Cracked Fuel Tank Inlet Control Valve**

**Models: 2006-2008 Chevrolet Cobalt  
2006 Pontiac Pursuit, G4  
2007-2008 Pontiac G5  
2006-2007 Saturn ION**

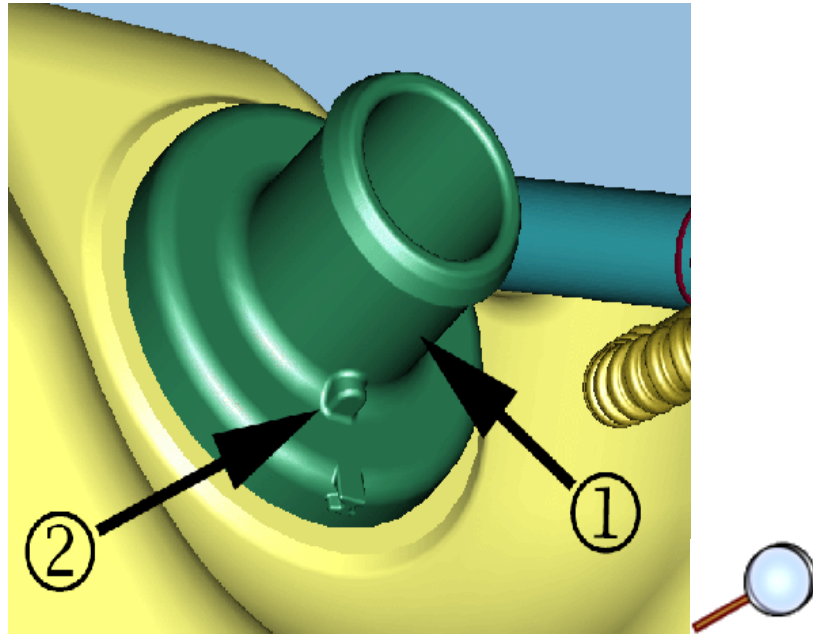
### Identifying the 20870462 or 25947828 fuel tank.

The fuel tank hose connection (1) will have an index feature (2) at the bottom 6 o'clock position where the hose joins the tank. Older style tanks have this feature on top at the 12 o'clock position. The fuel tank may also have an identifying tag displaying the part number.

- If the part number *is* 20870462 or 25947828, and has the bottom index, stop, this bulletin does not apply.
- If the part number *is not* 20870462 or 25947828, and has the top index, proceed to Steps 3 and 4.
