#PIP4549B: Various Intermittent DTCs Or Electrical / Communication Concerns - keywords bare battery camshaft chaff circuit class2 connection controls crank data DTC exhaust high intake light low message no open - (Feb 8, 2010)

Subject: Various Intermittent DTC's or Electrical/Communication Concerns

Models: 2005-2010 Chevrolet Cobalt SS

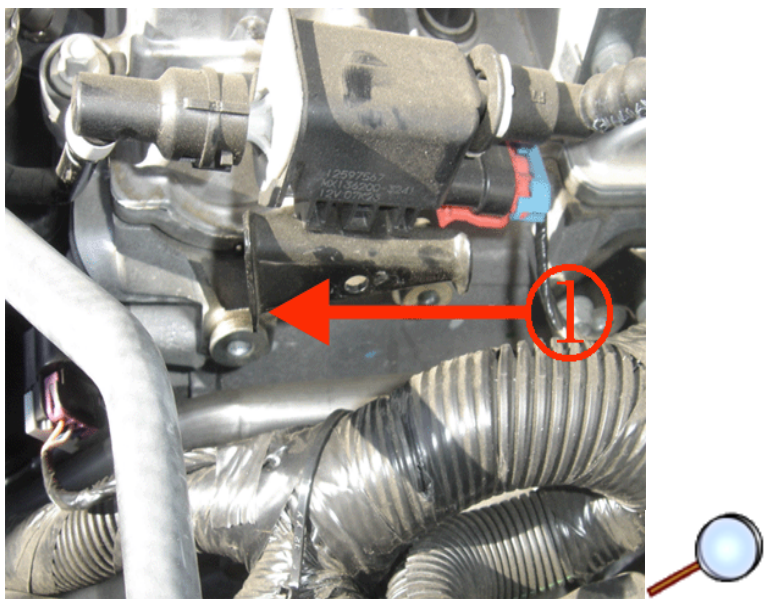
The harness may chaff in the area of the Canister Purge Solenoid attachment bracket, causing an intermittent shorting to ground. The harness routing forces the harness into the edge of the bracket. This bracket is present with any Ecotec engine. The Purge Solenoid bracket may have a sharp edge from the manufacturing/shearing operation. If any DTCs are setting consistently, perform the eSI diagnostics and repair as necessary. If the eSI diagnostics do not isolate the concern, inspect the engine harness for potential shorts to ground at the EVAP purge valve bracket on the side of the cylinder head. Then repair and reposition the circuits/harness as necessary.

Note: To prevent future chaffing remove the sharp edge from the purge solenoid bracket and add conduit to the engine harness at the ECM and Purge Solenoid harness breakout.
