#PIP4520: Low Boost / Power And/Or DTC P0299 Or P0101 - keywords actuator boost CAC charge control cooler driveability DTC ECM engine gas Inf low maf MIL reduced reducedpwmde SES wastegate - (Nov 4, 2008)

Subject: Low Boost/Power and/or DTC P0299 or P0101

Models: 2008-2009 Chevrolet Cobalt SS Only 2008-2009 Chevrolet HHR SS Only 2007-2009 Pontiac Solstice GXP 2007-2009 Saturn Sky Redline With Engine RPO LNF Only

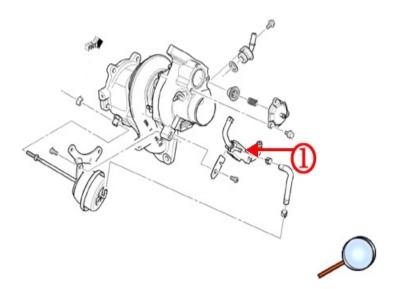
A technician may encounter a vehicle with a low boost/power condition and/or DTC P0299 and or P0101 setting. This may be the result of a cracked or broken fitting at the turbocharger assembly.

It has been determined that the nipple for the turbocharger wastegate actuator may be damaged causing this condition. If this concern is noted please inspect the area on the underside of the turbo compressor housing for the wastegate actuator solenoid valve. The nipple (see CALLOUT #1) may have been damaged causing a loss of boost pressure. It may be necessary to remove the charge air duct for a closer inspection. See eSI "Turbocharger Wastegate Actuator Replacement" for solenoid replacement procedure.

This solenoid is available separate from the turbocharger and should be replaced as a sub assembly. Do not replace the turbocharger assembly.
