#12191B: Special Coverage Adjustment - Fuel Odor or Spotting on Ground -Replace Fuel Pump Module - (Jul 8, 2015)

Models: 2006-2009 Chevrolet Cobalt

2007 Chevrolet Equinox 2006 Pontiac Pursuit **2007 Pontiac Torrent** 2007-2009 Pontiac G5 2006-2007 Saturn ION

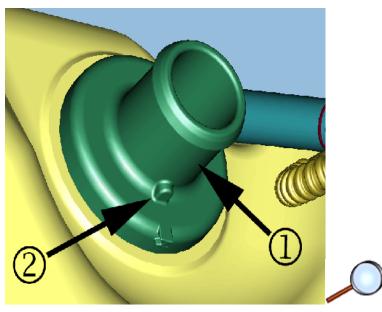
Identifying the 20870462 or 25947828 fuel tank

The fuel tank hose connection (1) will have an index feature (2) at the bottom 6 O'clock position where the hose joins the tank. Older style tanks have this feature on top at the 12 O'clock location. The fuel tank may also have an identifying tag displaying the part number.

If the part number is 20870462 or 25947828, and has the bottom index, do not replace the fuel tank or fill pipe.

3. If the part number is not 20870462 or 25947828, and has the top index, replace the fuel tank and fill pipe or fill hose as applicable. For 2006-2008 Chevrolet Cobalt, Pontiac Pursuit, G5: Remove the fuel tank filler pipe. Refer to Fuel Tank Filler Pipe Replacement in SI.

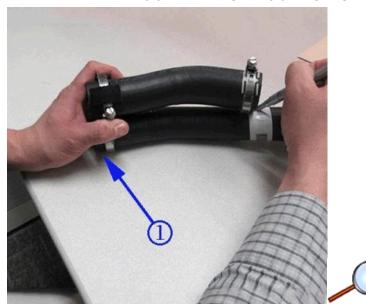
Note: When cutting the hose, be sure the cut is as straight as possible. Use a hose clamp or tape as a guide. Failure to cut the hose straight could result in leaks.

3.3. Using a paint pen or equivalent, mark the new hose to the original, starting with the notched fuel tank ends of the hoses so that both hoses are the same length.

3.4. Cut the hose **from the fill end** opposite of the side with the notch (1) to match the length.
