#14728B: Special Coverage Adjustment - Cracked Fuel Tank Inlet Control Valve - (Sep 17, 2015)

Subject: 14728B – Special Coverage Adjustment – Cracked Fuel Tank Inlet Control Valve

Models: 2006-2008 Chevrolet Cobalt

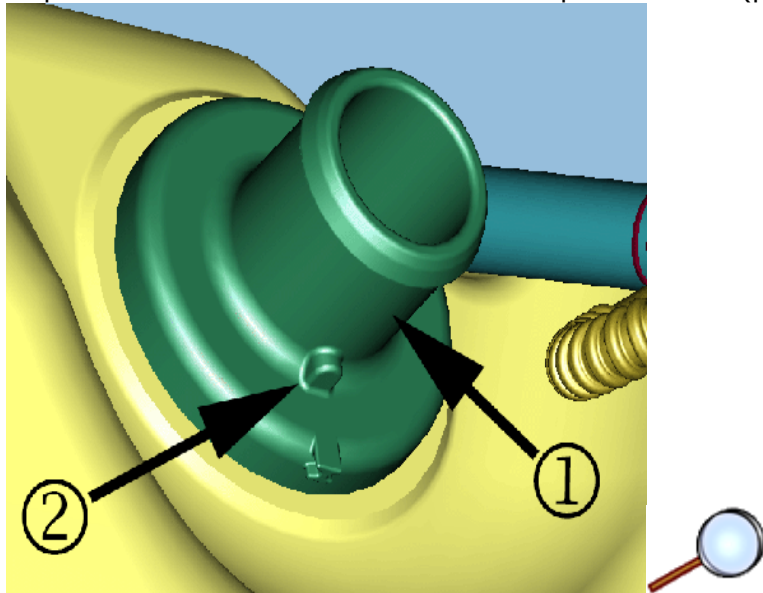
Identifying the 20870462 or 25947828 fuel tank.

The fuel tank hose connection (1) will have an index feature (2) at the bottom 6 o'clock position where the hose joins the tank. Older style tanks have this feature on top at the 12 o'clock position. The fuel tank may also have an identifying tag displaying the part number.

- If the part number *is* 20870462 or 25947828, and has the bottom index, stop, this bulletin does not apply.
 - If the part number *is not* 20870462 or 25947828, and has the top index, proceed to Steps 3 and 4.
3. Replace the fuel tank with p/n 20870462 or 25947828 as applicable. Refer to *Fuel Tank Replacement in SI*.
4. Replace the filler pipe.
- **Cobalt, G4, G5, Pursuit ONLY:** Use p/n 20757861 fill pipe assembly. Refer to *Filler Tube Replacement in SI*.
 - **ION ONLY: Trim new hose p/n 20757866 to match existing fuel fill hose.**
1. Remove **fuel fill hose** from vehicle mounted fill pipe.
