#09-09-40-003A: SIR/Airbag Light Illuminated, DTC B0081 and Passenger Presence System (PPS) Code 23 Stored (Replace Passenger Seat Belt Retractor and Re-Route Wire Harness) - (Jul 26, 2010)

Subject: SIR/Airbag Light Illuminated, DTC B0081 and Passenger Presence System (PPS) Code 23 Stored (Replace Passenger Seat Belt Retractor and Re-Route Wire Harness)

Models: 2006-2008 Chevrolet Cobalt Coupe
2008-2010 Chevrolet Cobalt SS Coupe
2006 Pontiac Pursuit Coupe (Canada Only)
2007-2010 Pontiac G5 Coupe

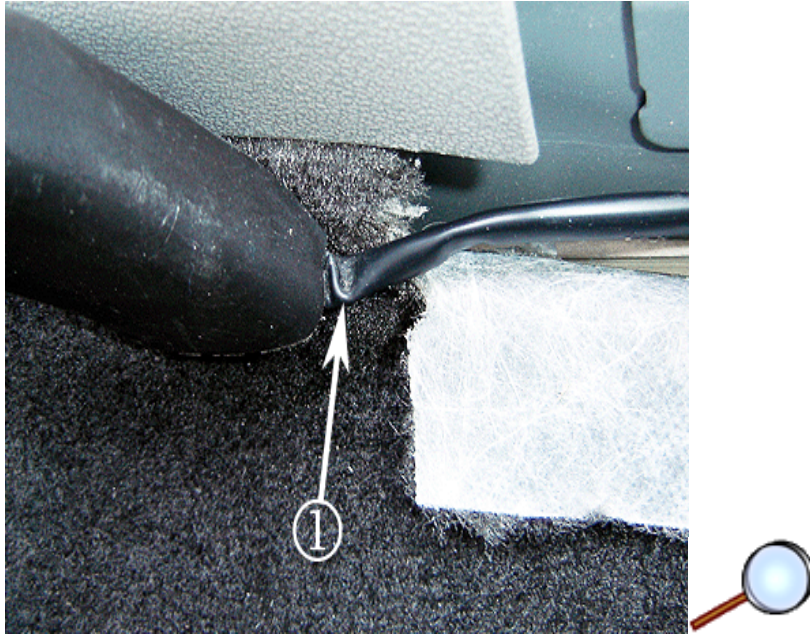
Figure 1 – Stress Point on Wiring Bundle

The wire on the Belt Tension Sensor (BTS), that is part of the retractor assembly, may become open or acquire a ground near the sensor. If the BTS is rotated toward the rear of the vehicle, added stress is applied to the wire bundle that may cause an open or a ground path. The two photos below illustrate the possible effects on the wiring. Each photo indicates the area to investigate at the arrow labeled (1).
