#16-NA-383: Information on Rough Idle, Crank No Start, Extended Crank or Misfire Due to Excessive Carbon on Top of the Valves or Sticking Valves, Malfunction Indicator Lamp (MIL) Illuminated - DTC P0300, P0301, P0302, P0303, P0304, P0305, P0306, P0307, P0308 Set - (May 10, 2017)

This Bulletin replaces PIP5029H. Please discard PIP5029H.

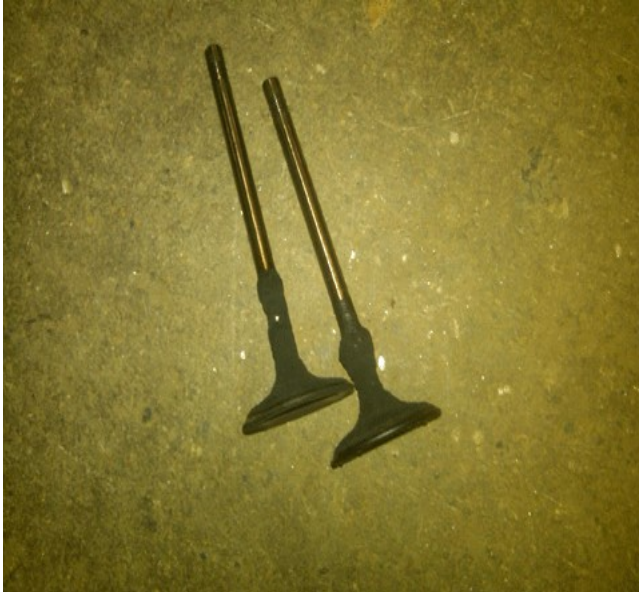
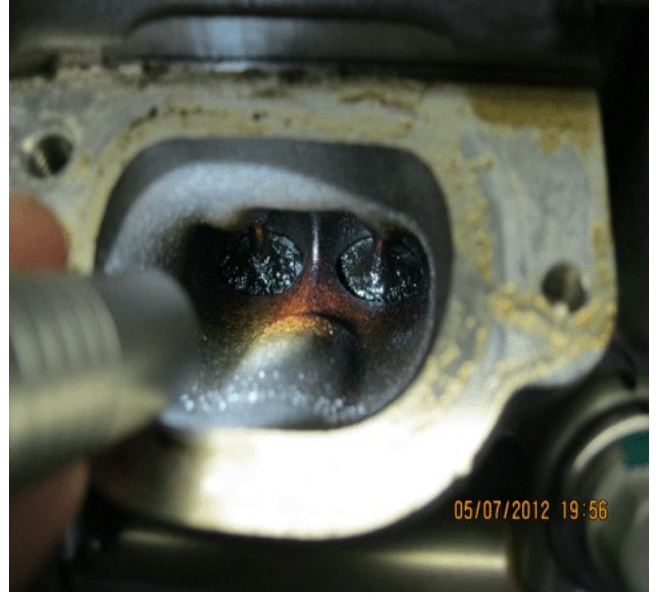
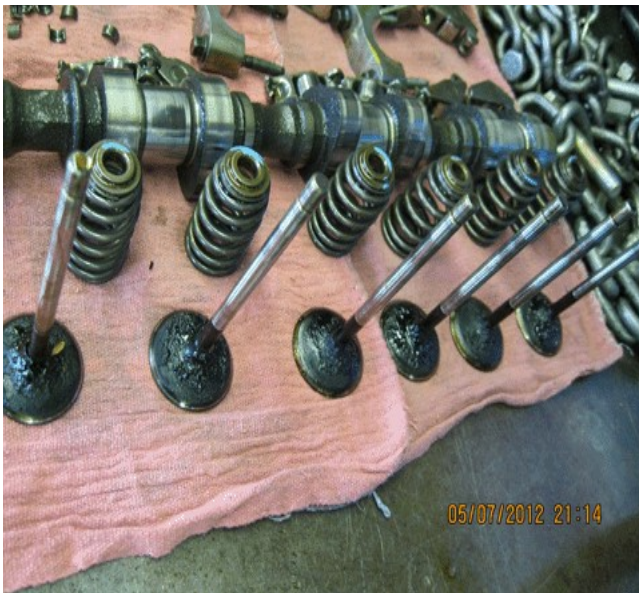
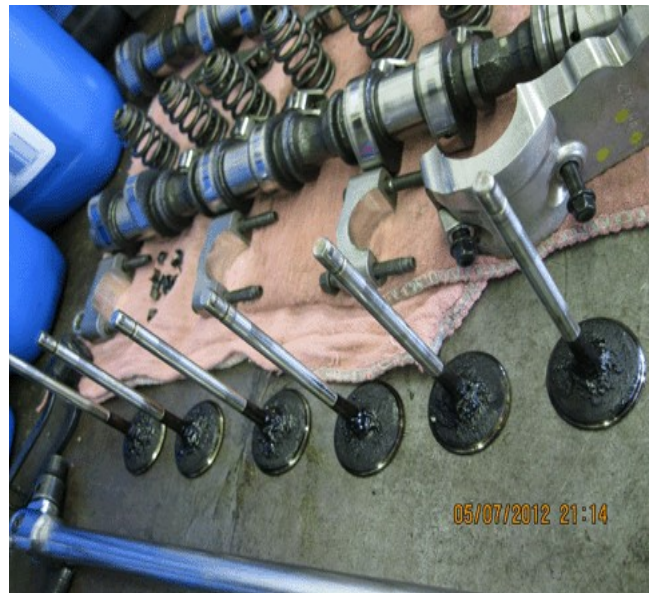
| Cause | <p>This condition may be caused by major carbon build up on the intake and/or exhaust valves due to fuel contamination or incomplete burning of the fuel as shown below so the misfires should not have appeared until accumulating at least 5,000 miles (8,000 kilometers) or more.</p> |

The graphics below may show typical carbon build-up during engine dissemble and inspection of the cylinder heads:

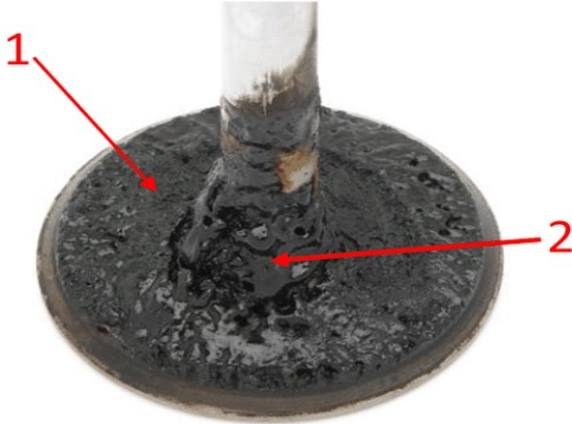
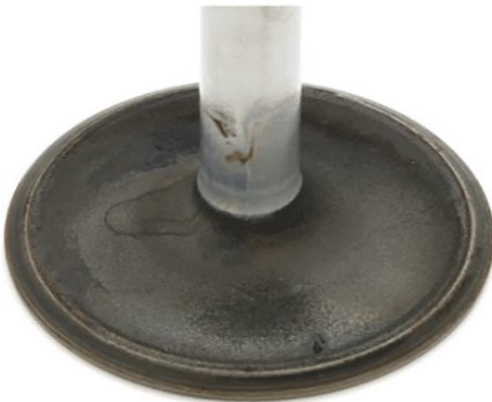
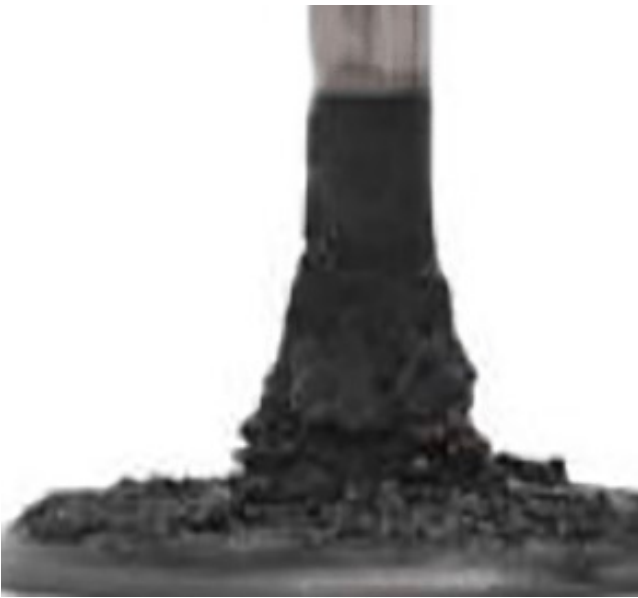
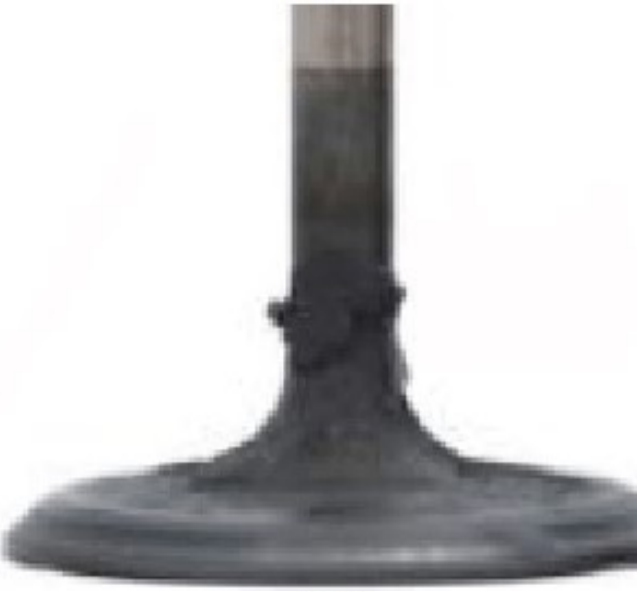
| Before Cleanup | After Cleanup |

- If valve damage is present or if there are cam followers that are out of place, perform engine mechanical repairs as necessary to correct the concern and then perform the procedure below to prevent the concern from returning.
- Perform an upper engine and valve cleaning procedure.
- Below are examples of valves that have gone through a top engine cleaning procedure.
